NASA Contractor Report 189120
MTI Report 91TR56

Heat Pipe Fatigue Test Specimen Metallurgical Evaluation

Steven E. Walak and Michael J. Cronin
Mechanical Technology Incorporated
Latham, New York

January 1992

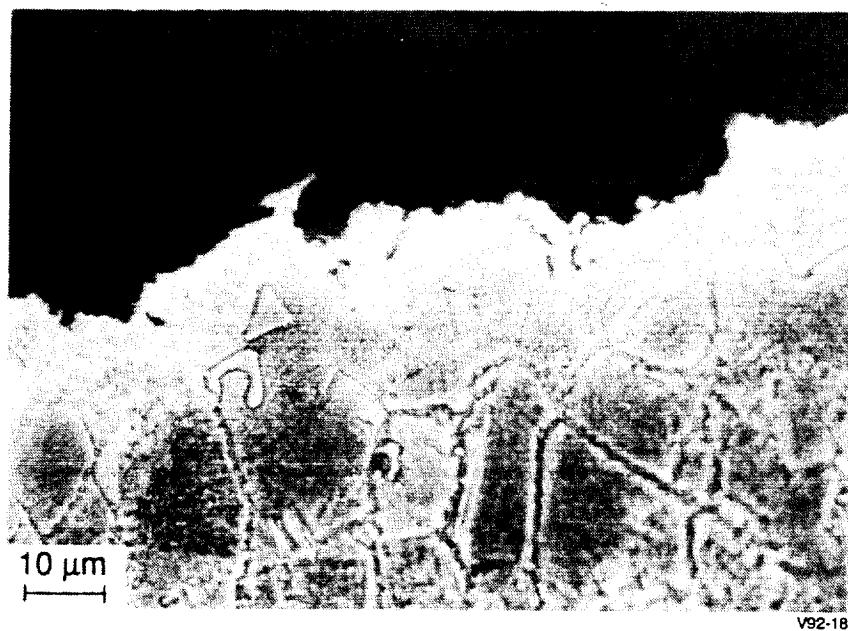
Scanning electron microscopy was used to examine the heat pipe wall for evidence of surface corrosion. Fine surface pits, <1.5 μm (60 $\mu\text{in.}$) in diameter, were observed at the evaporator base to a height of approximately 25.4 mm (1.0 in.) (see Figure 13). The pitted region corresponded with the region of the wick that was coated with the vanadium-containing deposits. Exposure to excess sodium liquid accumulated at the base of the evaporator appears to be the reason for the surface changes observed in this region. The maximum depth of the fine surface pits was <10 μm (400 $\mu\text{in.}$) as revealed by metallographic sections (Figure 14). The intensity of pitting gradually decreased at distances greater than 25.4 mm (1.0 in.) from the evaporator base and no fine surface pits were observed above approximately 51 mm (2 in.) (Figure 15).

Figure 14. Optical Micrograph of Fine Surface Pitting on Heat Pipe Wall at Evaporator Base
